**Flood Control Project Maintenance
Levee Inspections**

Fall 2010 Levee Maintenance Deficiency Summary Report

San Joaquin River Basin

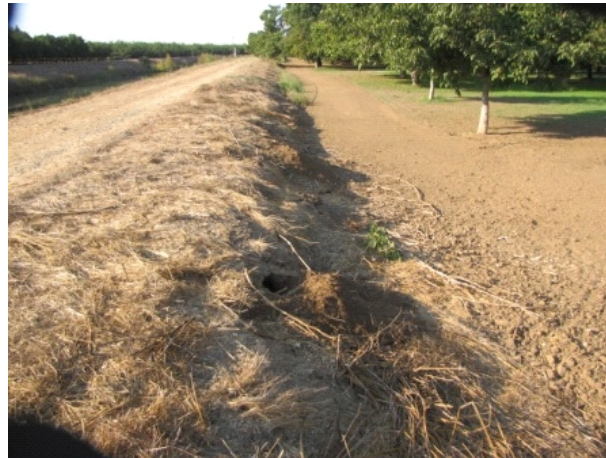
View of rodent activity in the landward slope looking downstream.

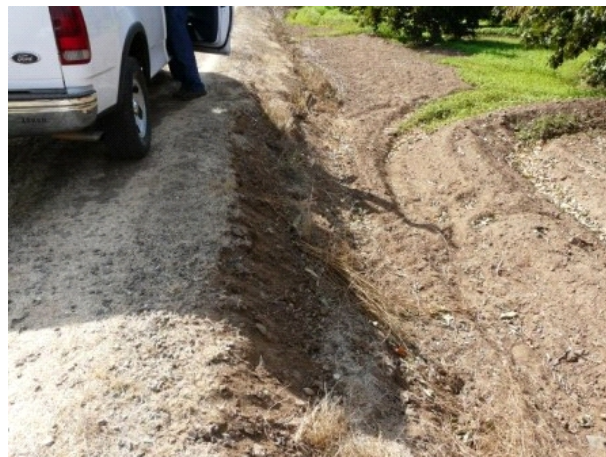
Levee Mile Report Line	76
Start Levee Mile	6.75
End Levee Mile	6.88
Location	Land Side
Category	Earthen Levee
Item	Erosion / Bank Caving

Farming equipment grading into the landside toe of the levee located at LM 6.90. Backfill and compact to design shape and attempt to prevent future damage.

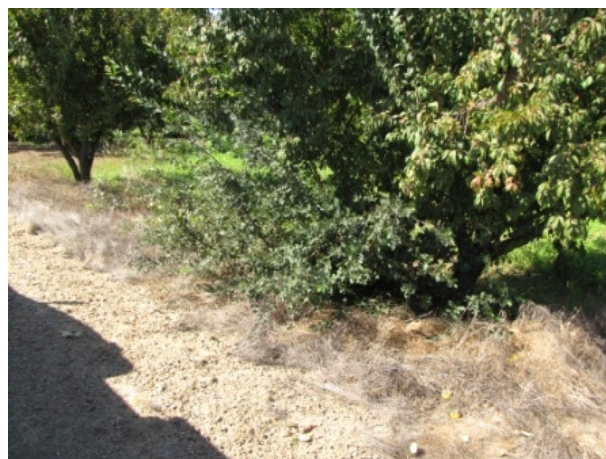
Levee Mile Report Line	78
Start Levee Mile	6.91
End Levee Mile	6.91
Location	Land Side
Category	Earthen Levee
Item	Trim / Thin Trees

View of trees obstructing visibility and the ability to floodfight along the landward slope.

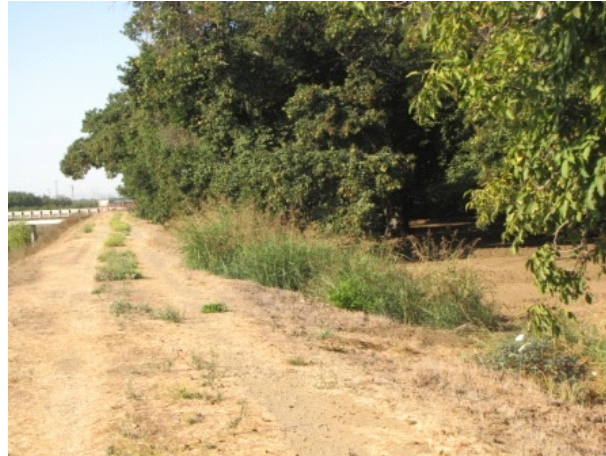
View of vegetation on the landward slope blocking visibility looking downstream.

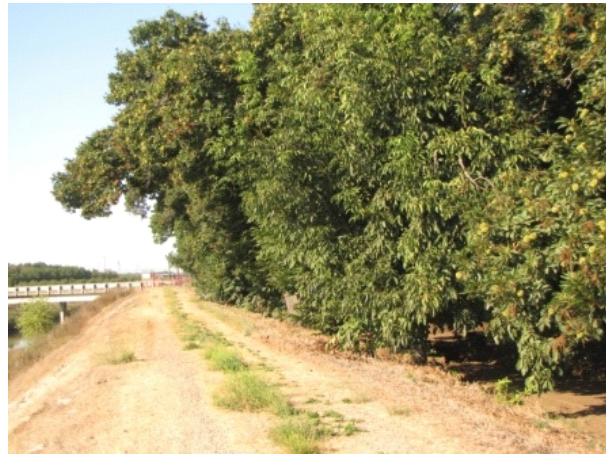
Levee Mile Report Line	80
Start Levee Mile	6.98
End Levee Mile	7.06
Location	Land Side
Category	Earthen Levee
Item	Trim / Thin Trees

View of tree branches on the landward slope blocking visibility looking downstream.

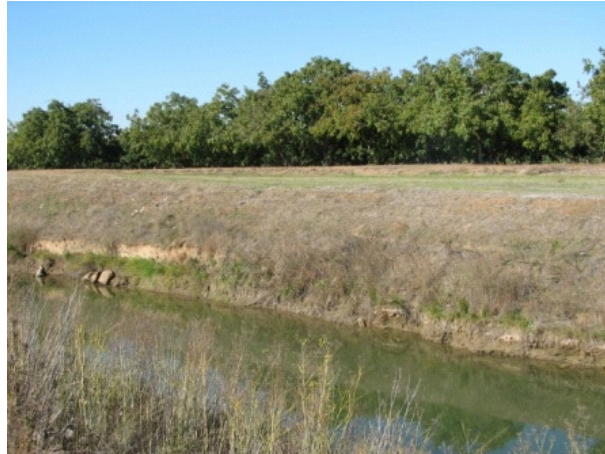
Levee Mile Report Line	81
Start Levee Mile	7.23
End Levee Mile	7.23
Location	Water Side
Category	Supplemental
Item	DWR Erosion Survey

Looking downstream at the bank scarp. Minor erosion is not affecting the levee due to a wide berm.

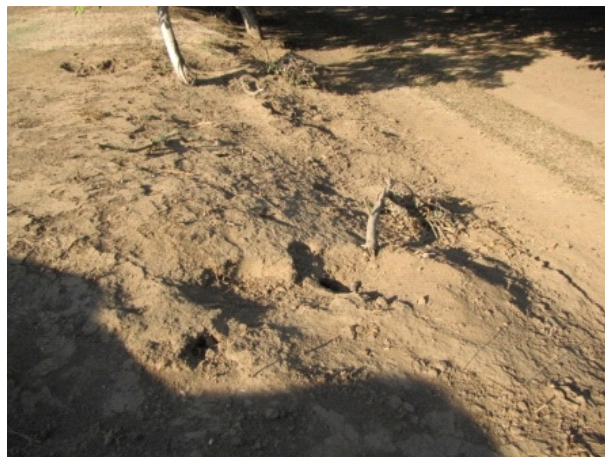
Levee Mile Report Line	82
Start Levee Mile	7.24
End Levee Mile	7.29
Location	Land Side
Category	Earthen Levee
Item	Animal Control

View of rodent activity in the landward slope looking downstream.

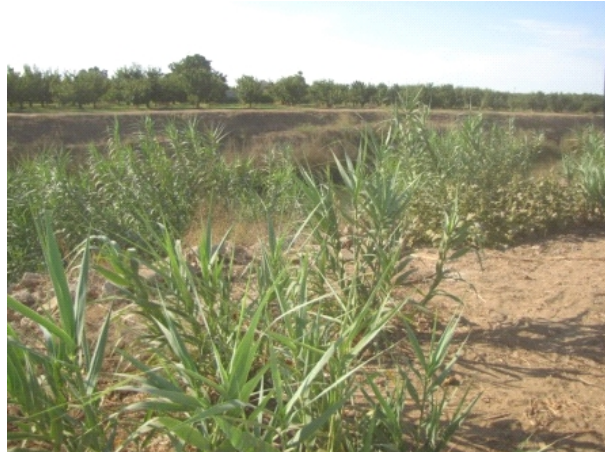
Levee Mile Report Line	89
Start Levee Mile	8.06
End Levee Mile	8.06
Location	Water Side
Category	Earthen Levee
Item	Vegetation
View of arrundo on the waterward shoulder and slope blocking visibility looking downstream.	
dpesaven_f_20101003_443.jpg

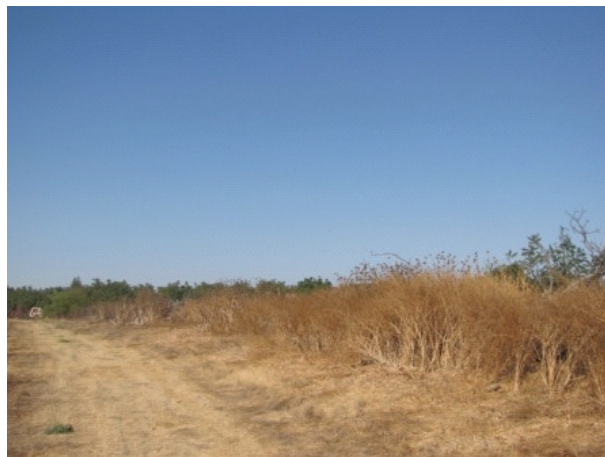
Levee Mile Report Line	91
Start Levee Mile	8.62
End Levee Mile	8.65
Location	Crown
Category	Earthen Levee
Item	Encroachments
View of vegetation and prunings on what is believed to be the crown of the levee looking downstream.	
dpesaven_f_20101003_444.jpg

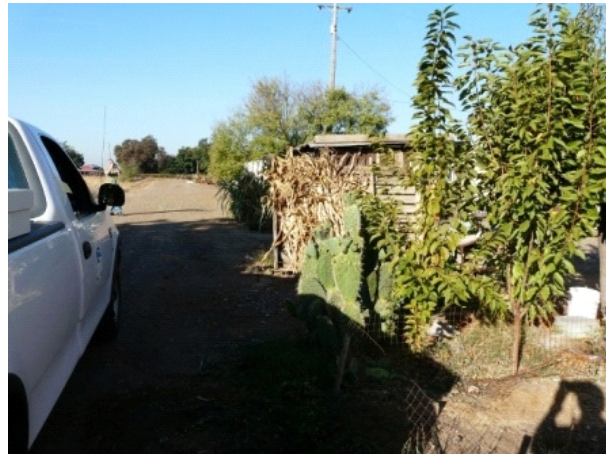
Levee Mile Report Line	94
Start Levee Mile	8.72
End Levee Mile	8.72
Location	Land Side
Category	Earthen Levee
Item	Encroachments
Building, fence and landscaping immediately adjacent to the access road at LM 8.72.	
dpesaven_f_20100928_263.JPG

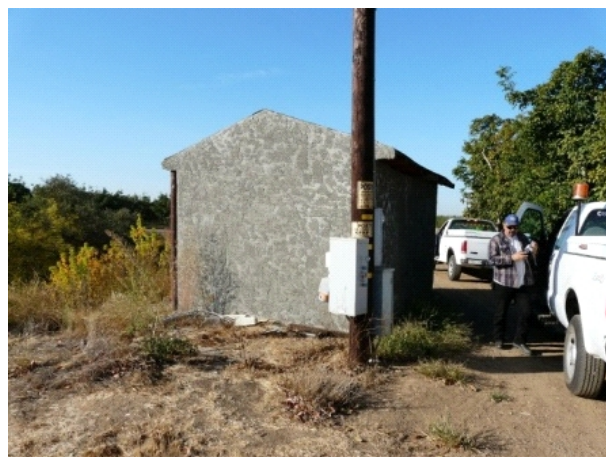
Levee Mile Report Line	101
Start Levee Mile	9.63
End Levee Mile	9.63
Location	Water Side
Category	Earthen Levee
Item	Encroachments
Building located at LM 9.63 on waterside of access road. This building appears to be recently constructed and does not currently contain anything.	
dpesaven_f_20100928_247.JPG

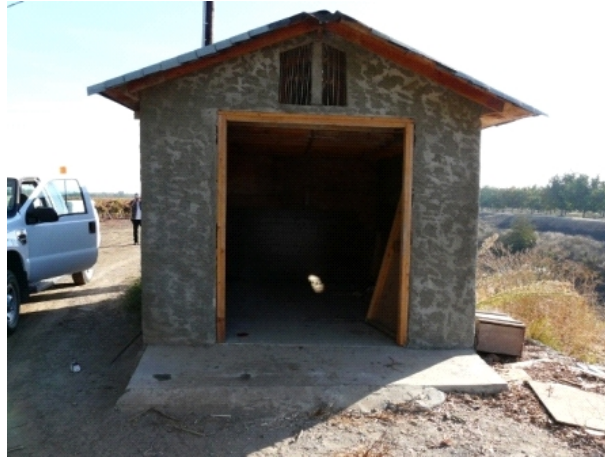
Additional view of building at LM 9.63.

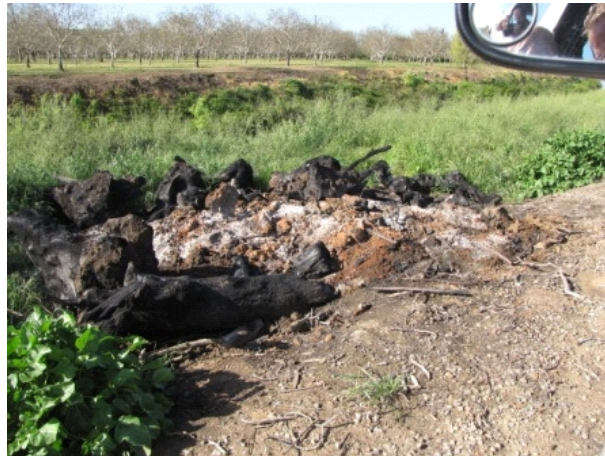
Levee Mile Report Line	108
Start Levee Mile	10.62
End Levee Mile	10.62
Location	Water Side
Category	Earthen Levee
Item	Encroachments

View of the prunings pile on the waterward slope looking downstream.

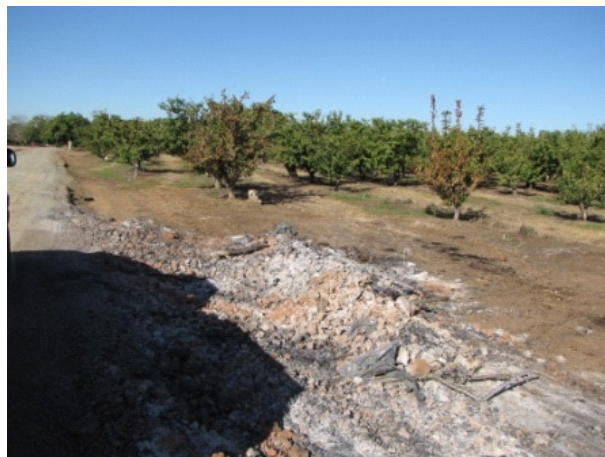
Levee Mile Report Line	109
Start Levee Mile	10.67
End Levee Mile	10.67
Location	Land Side
Category	Earthen Levee
Item	Encroachments

View of debris left from a burn pile on the landward side of the levee looking downstream.

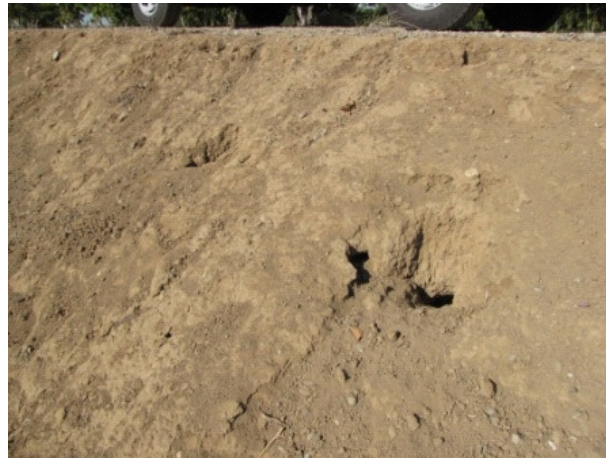
View of rodent holes in the waterward slope.

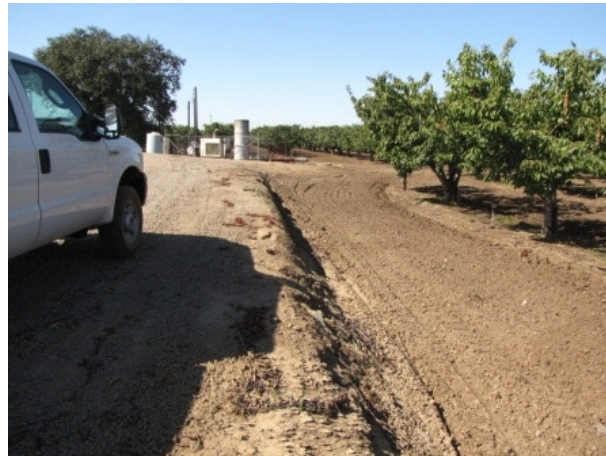
Levee Mile Report Line	115
Start Levee Mile	11.26
End Levee Mile	11.48
Location	Land Side
Category	Earthen Levee
Item	Erosion / Bank Caving

View of the damage caused to the levee by a farmer's tilling activity looking downstream.

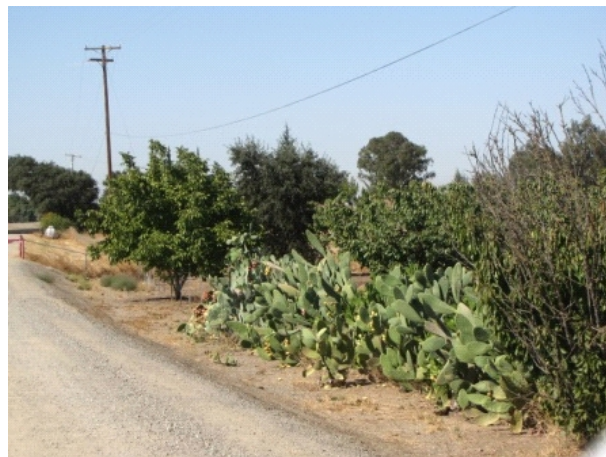
Levee Mile Report Line	116
Start Levee Mile	11.61
End Levee Mile	11.61
Location	Land Side
Category	Earthen Levee
Item	Encroachments

View of cactus within 10 feet of the landward toe blocking visibility and access.

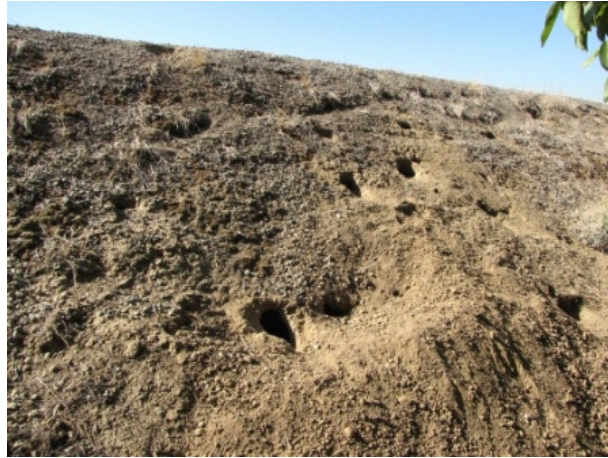
View of rodent holes in the landward slope of the levee.

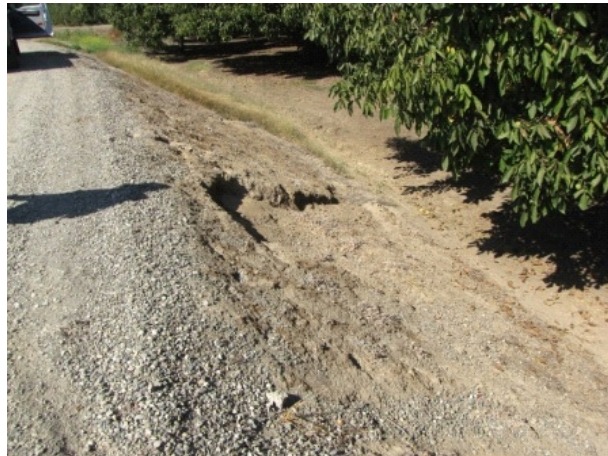
Levee Mile Report Line	122
Start Levee Mile	12.80
End Levee Mile	12.80
Location	Water Side
Category	Earthen Levee
Item	Erosion / Bank Caving

View of erosion occurring on the landward slope looking downstream.

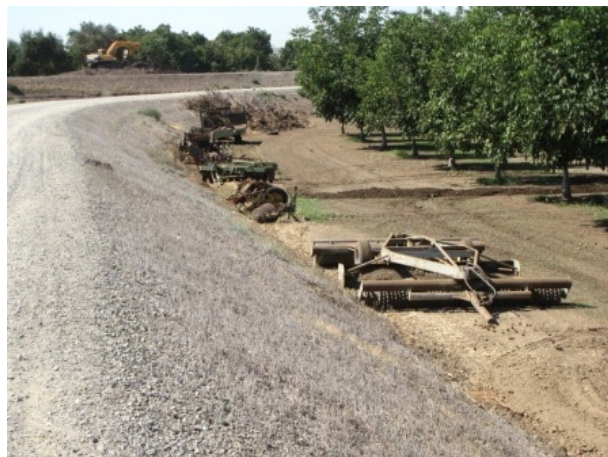
Levee Mile Report Line	132
Start Levee Mile	13.54
End Levee Mile	13.54
Location	Land Side
Category	Earthen Levee
Item	Encroachments

View of equipment within 10 feet of the landward toe looking downstream. The resident stated it would be moved in a few weeks.

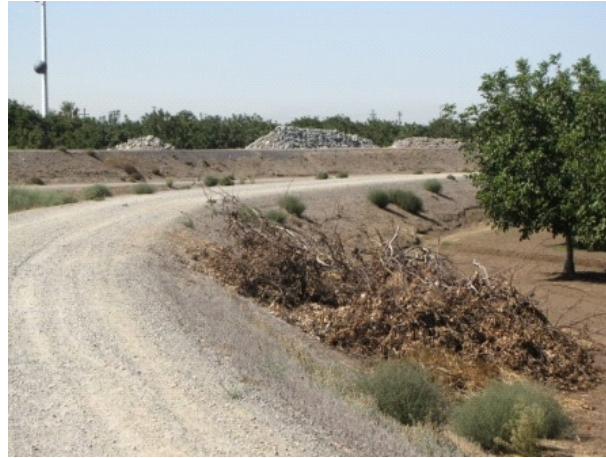
dpesaven_f_20101003_449.jpg

View of a prunings pile on the landward slope looking downstream. The resident stated it would be moved in a few weeks.

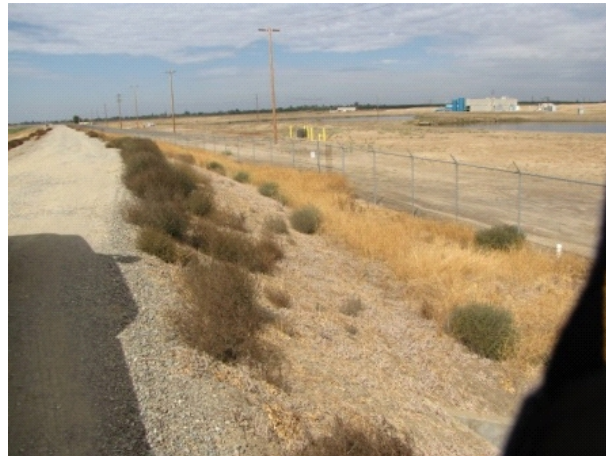
Levee Mile Report Line	135
Start Levee Mile	13.78
End Levee Mile	14.98
Location	Land Side
Category	Earthen Levee
Item	Vegetation

View of vegetation on the landward slope and toe blocking visibility looking downstream.

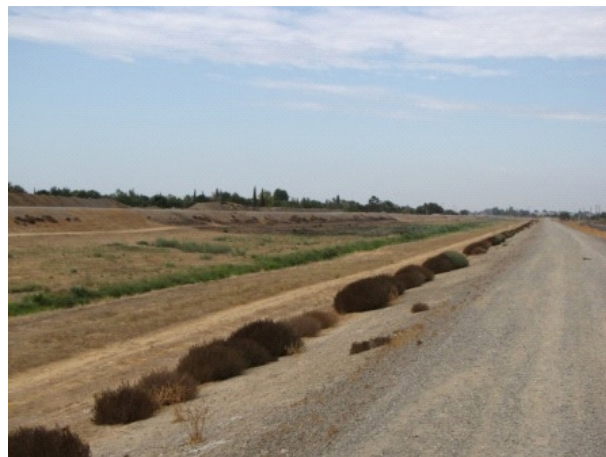
Levee Mile Report Line	136
Start Levee Mile	13.95
End Levee Mile	14.41
Location	Water Side
Category	Earthen Levee
Item	Vegetation

View of vegetation blocking visibility along the waterward slope looking downstream.

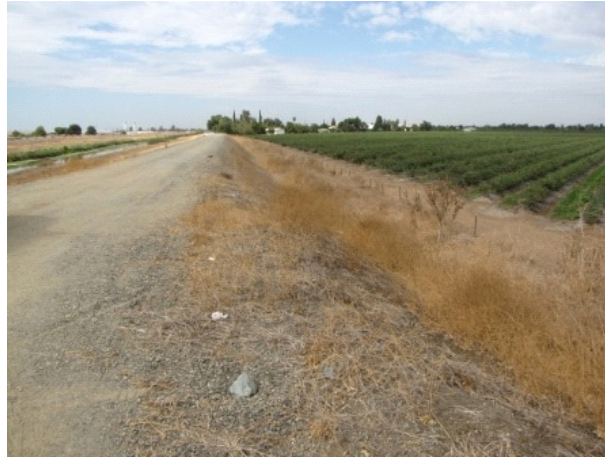
dpesaven_f_20101006_465.jpg

View of vegetation on the landward slope looking upstream.

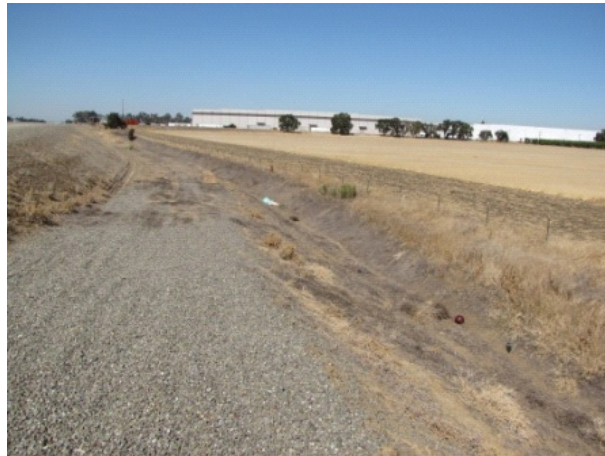
Levee Mile Report Line	143
Start Levee Mile	16.09
End Levee Mile	16.60
Location	Land Side
Category	Earthen Levee
Item	Encroachments

View of a ditch adjacent to the landward toe looking downstream.

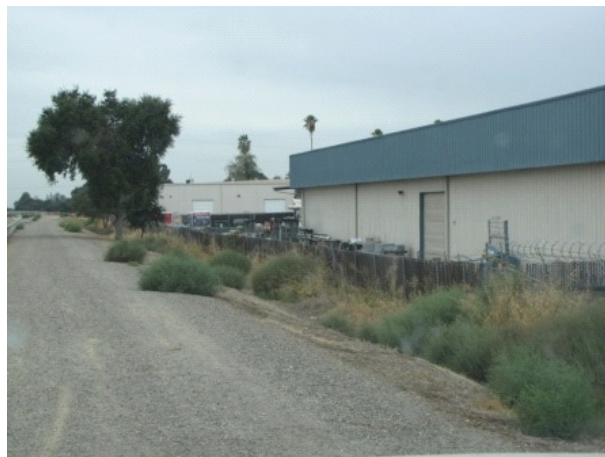
Levee Mile Report Line	148
Start Levee Mile	16.90
End Levee Mile	17.18
Location	Land Side
Category	Earthen Levee
Item	Vegetation

View of vegetation blocking visibility along the landward slope looking downstream.

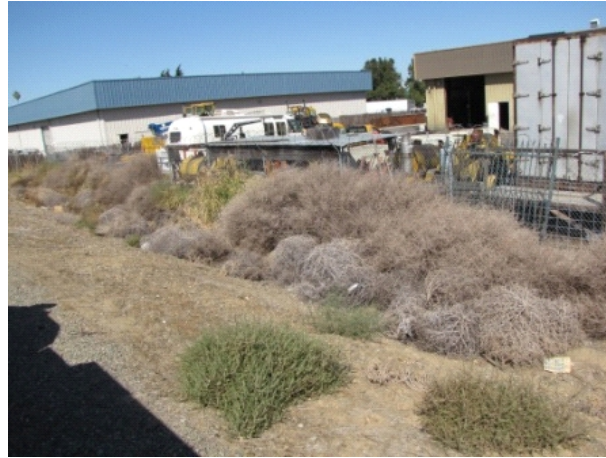
dpesaven_f_20100928_290.jpg

View of vegetation blocking visibility and access along the landward toe looking downstream.

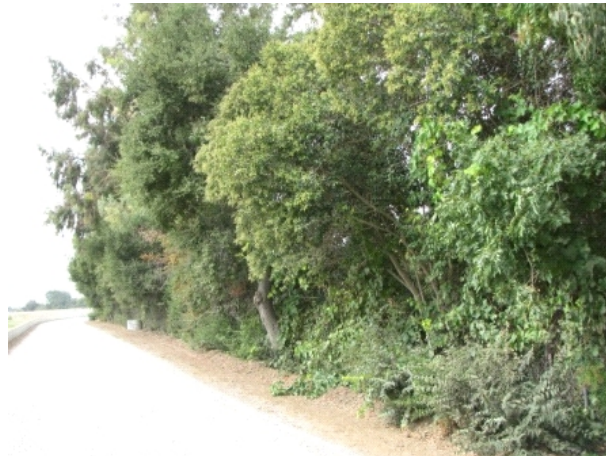
Levee Mile Report Line	154
Start Levee Mile	17.97
End Levee Mile	18.04
Location	Land Side
Category	Earthen Levee
Item	Encroachments

View of landowner's trees and plants blocking visibility on the landward side of the levee looking downstream.

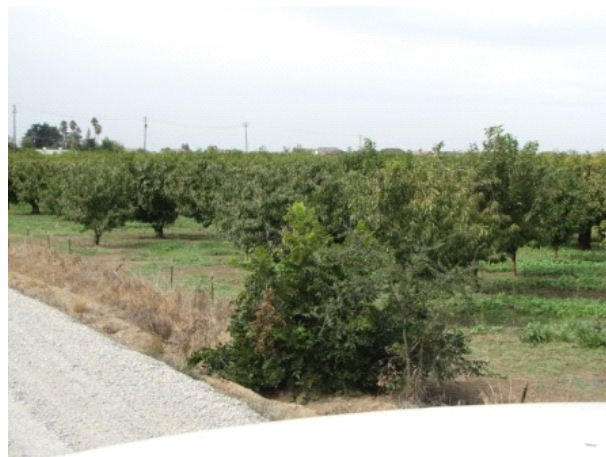
Levee Mile Report Line	157
Start Levee Mile	18.10
End Levee Mile	18.10
Location	Land Side
Category	Earthen Levee
Item	Trim / Thin Trees

View of a small clump of trees on the landward slope blocking visibility and access looking downstream.

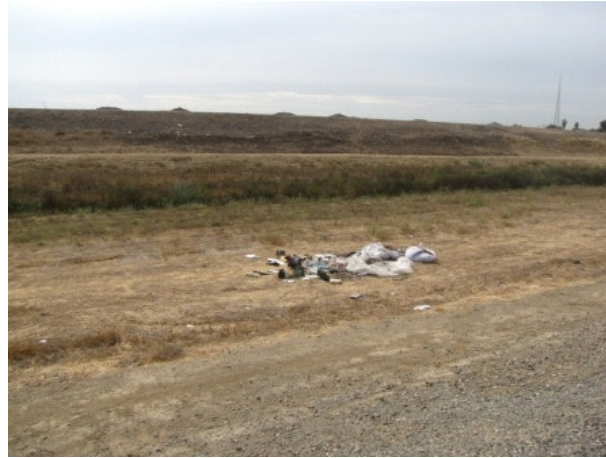
dpesaven_f_20101006_469.jpg

View of debris on the waterward side of the levee looking downstream.

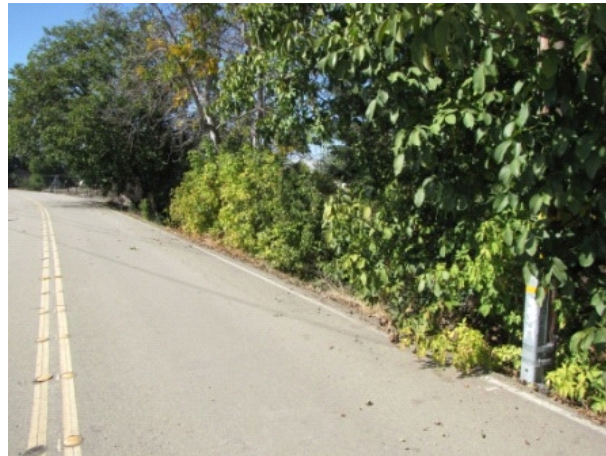
Levee Mile Report Line	160
Start Levee Mile	18.54
End Levee Mile	18.55
Location	Land Side
Category	Earthen Levee
Item	Encroachments

View of landowner planted and maintained vegetation along the landward slope looking downstream.

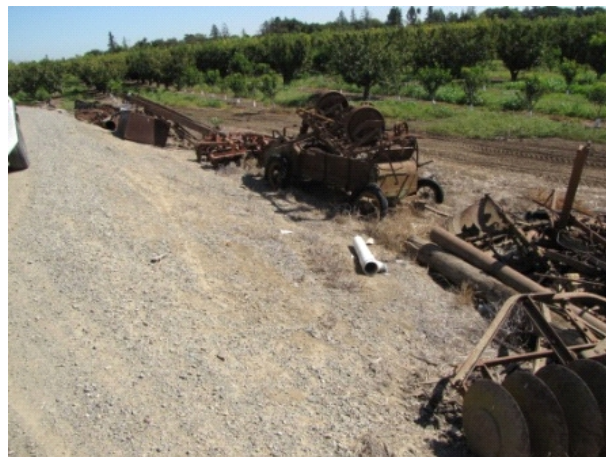
Levee Mile Report Line	162
Start Levee Mile	18.62
End Levee Mile	18.62
Location	Land Side
Category	Earthen Levee
Item	Encroachments

View of equipment on the landward slope and toe looking downstream.

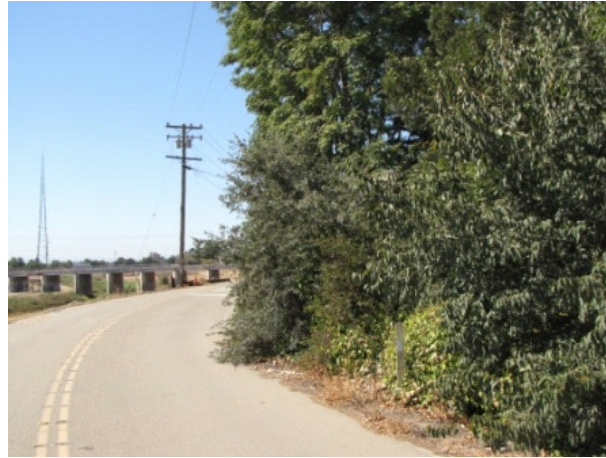
dpesaven_f_20100928_294.jpg

View of landowner planted and maintained vegetation along the landward slope looking downstream.

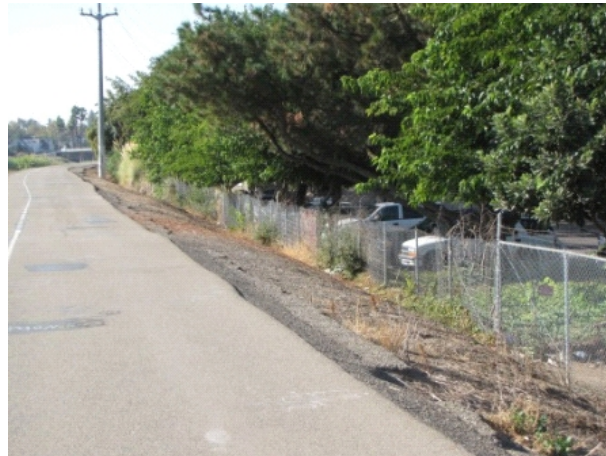
Levee Mile Report Line	175
Start Levee Mile	21.46
End Levee Mile	21.61
Location	Land Side
Category	Earthen Levee
Item	Encroachments

View of fence along the landward toe looking downstream.

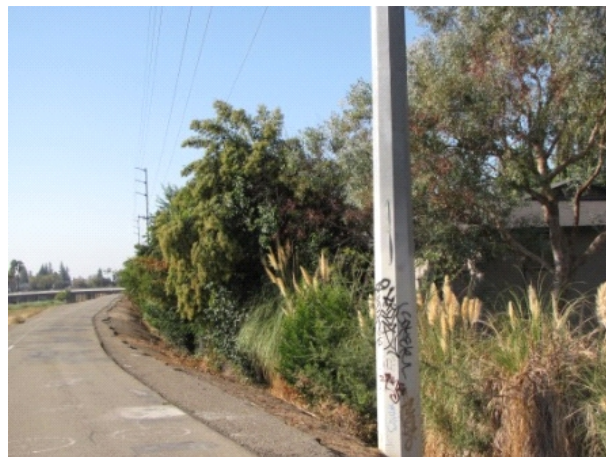
Levee Mile Report Line	176
Start Levee Mile	21.52
End Levee Mile	21.73
Location	Land Side
Category	Earthen Levee
Item	Encroachments

View of landscaping along the landward slope and toe looking downstream.

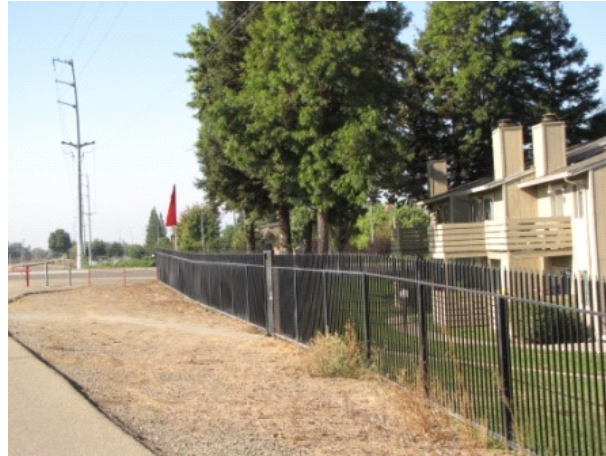
dpesaven_f_20100928_296.jpg

View of fence along the landward shoulder looking downstream.

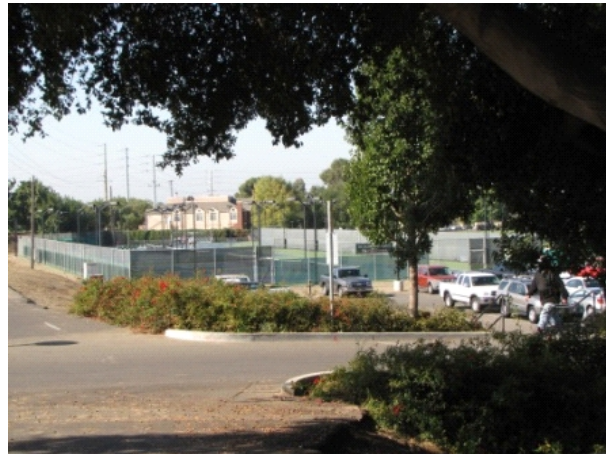
Levee Mile Report Line	178
Start Levee Mile	22.11
End Levee Mile	22.11
Location	Land Side
Category	Earthen Levee
Item	Encroachments

View of landscaping maintained by UOP along the landward slope looking downstream.

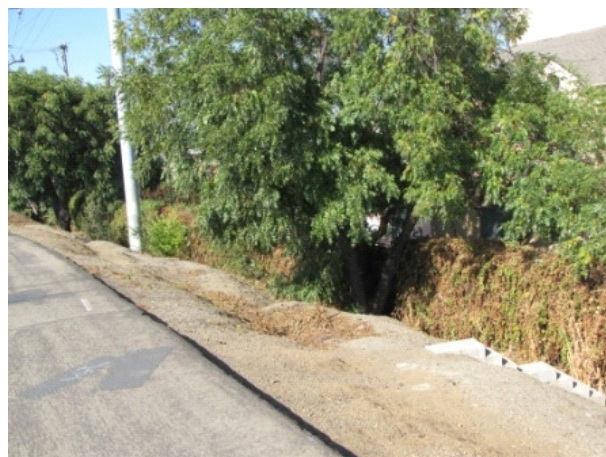
Levee Mile Report Line	180
Start Levee Mile	22.27
End Levee Mile	22.32
Location	Land Side
Category	Earthen Levee
Item	Encroachments

View of landscaping along the landward toe of the levee looking downstream.

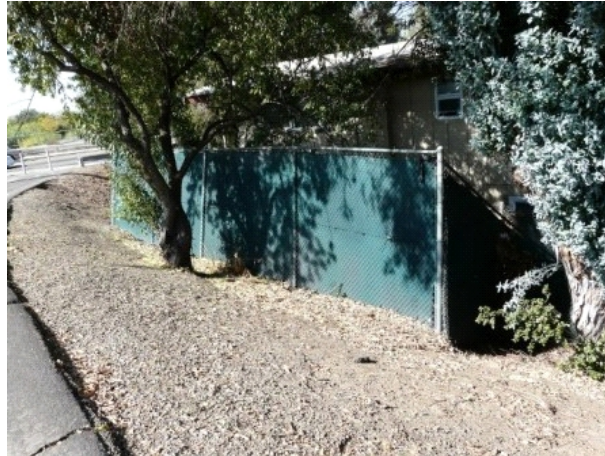
dpesaven_f_20100928_265.JPG

Fence located from LM 22.36 to LM 22.37 significantly encroaches onto landside levee slope.

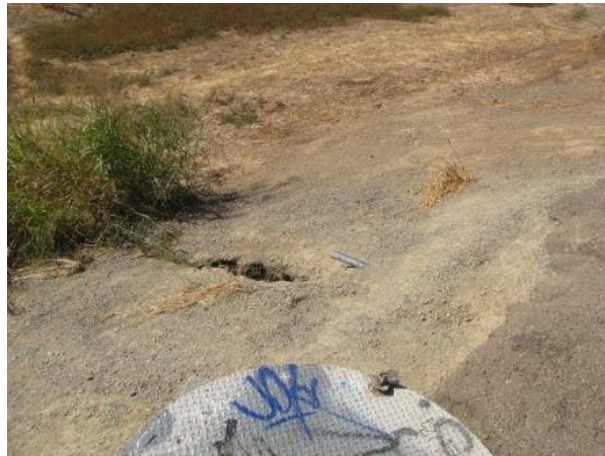
Levee Mile Report Line	183
Start Levee Mile	22.59
End Levee Mile	22.59
Location	Water Side
Category	Earthen Levee
Item	Erosion / Bank Caving

View of erosion occurring under a drain pipe for a vacuum breaker box on the waterward side of the levee looking downstream.

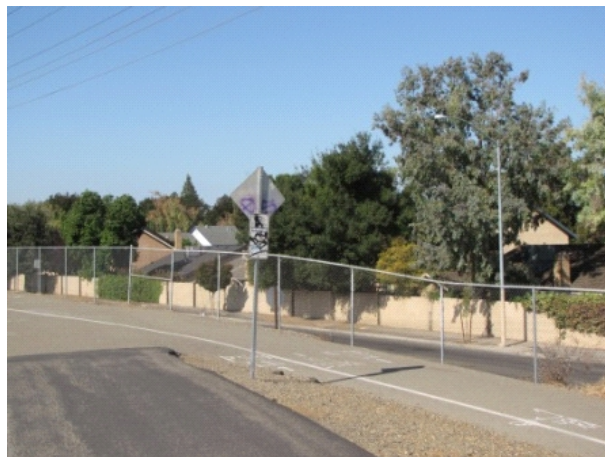
Levee Mile Report Line	184
Start Levee Mile	22.88
End Levee Mile	22.90
Location	Land Side
Category	Earthen Levee
Item	Encroachments

View of fence along the landward shoulder looking downstream.

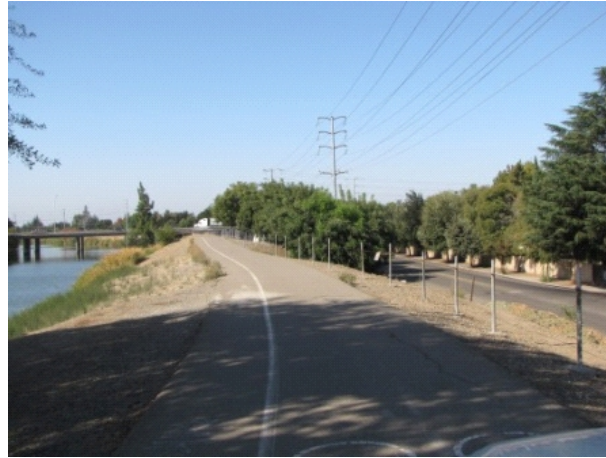
dpesaven_f_20100928_299.jpg

View of fence along landward shoulder looking downstream.

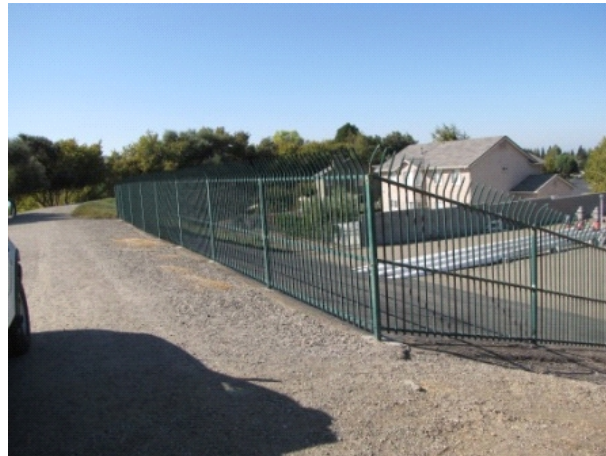
Levee Mile Report Line	186
Start Levee Mile	24.20
End Levee Mile	24.21
Location	Land Side
Category	Earthen Levee
Item	Encroachments

View of fence along the landward shoulder looking downstream.

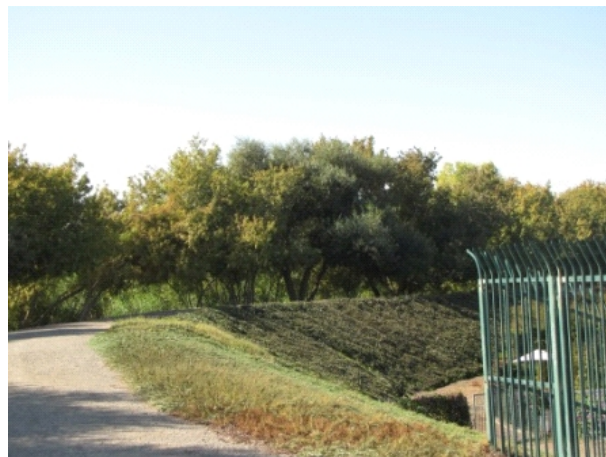
Levee Mile Report Line	187
Start Levee Mile	24.21
End Levee Mile	25.62
Location	Land Side
Category	Earthen Levee
Item	Encroachments

View of typical landowner planted and maintained landscaping and irrigation along the landward shoulder, slope, and toe looking downstream.

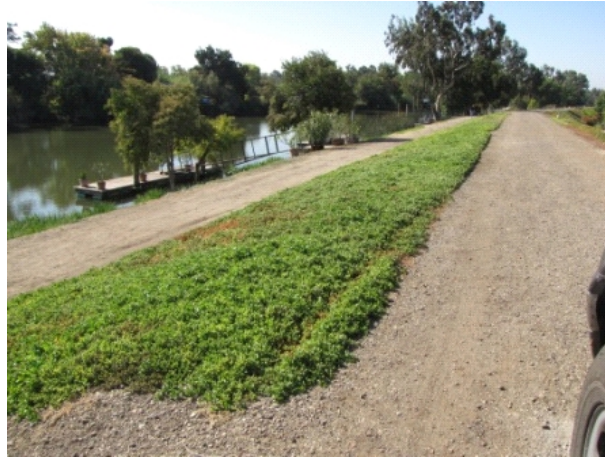
dpesaven_f_20100928_301.jpg

View of typical landowner planted and maintained landscaping and irrigation along the waterward shoulder and slope looking downstream.

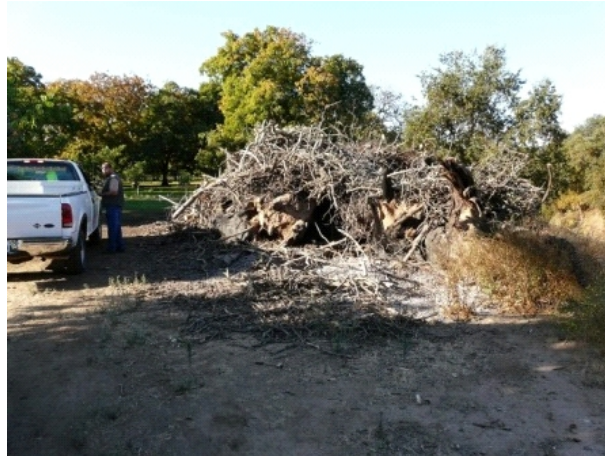
Levee Mile Report Line	2
Start Levee Mile	0.32
End Levee Mile	0.32
Location	Crown
Category	Earthen Levee
Item	Encroachments
<p>Prunings pile located at LM 0.32 on waterside shoulder of access road. The pile impedes access and forces vehicles to drive through orchard.</p>	
dpesaven_f_20100928_310.JPG

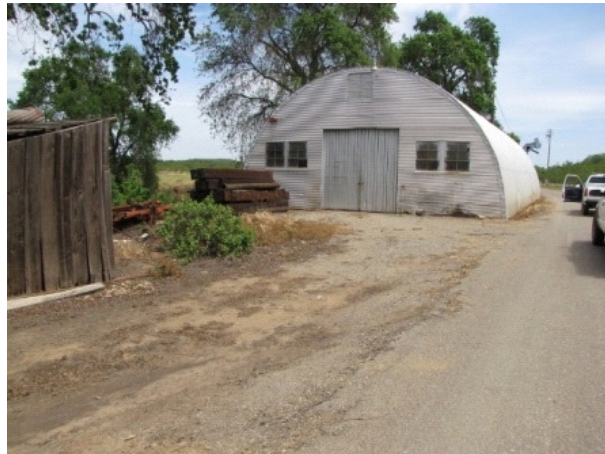
Levee Mile Report Line	3
Start Levee Mile	0.54
End Levee Mile	0.54
Location	Water Side
Category	Earthen Levee
Item	Encroachments
<p>Building/shed and other equipment located on waterward side of access road. There is no vehicle access adjacent to the channel.</p>	
dpesaven_f_20100928_323.jpg

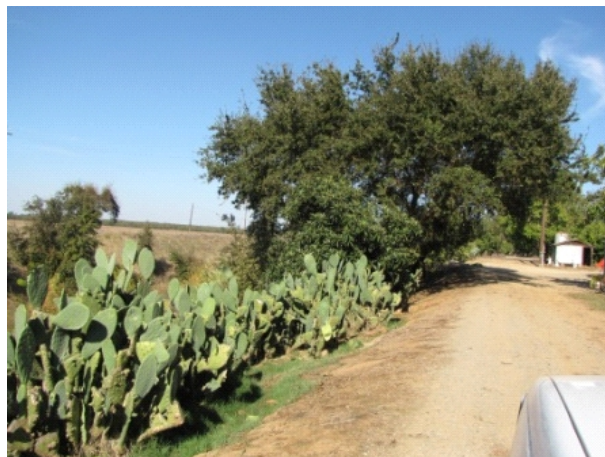
Levee Mile Report Line	7
Start Levee Mile	0.83
End Levee Mile	0.89
Location	Water Side
Category	Earthen Levee
Item	Encroachments
<p>View of landowner maintained landscaping on waterward side looking upstream.</p>	
dpesaven_f_20100928_368.jpg

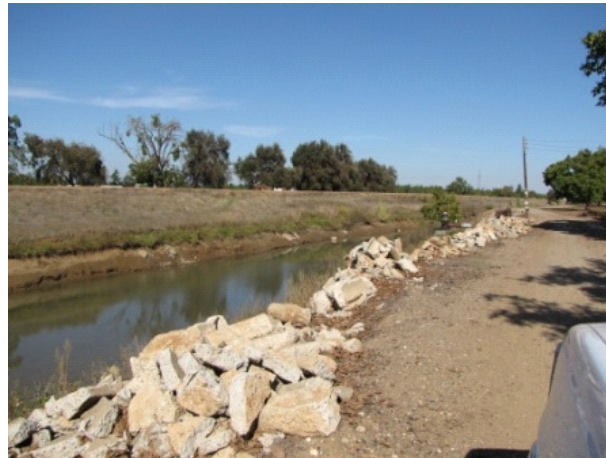
dpesaven_f_20100928_367.jpg

View of concrete debris on waterward side looking upstream.

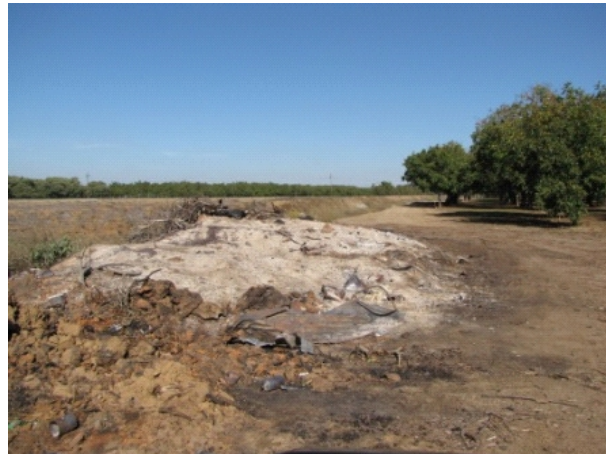
Levee Mile Report Line	17
Start Levee Mile	3.78
End Levee Mile	3.78
Location	Water Side
Category	Earthen Levee
Item	Encroachments

View of burn pile that has been burned and a location where a landowner recently removed prunings as requested looking upstream.

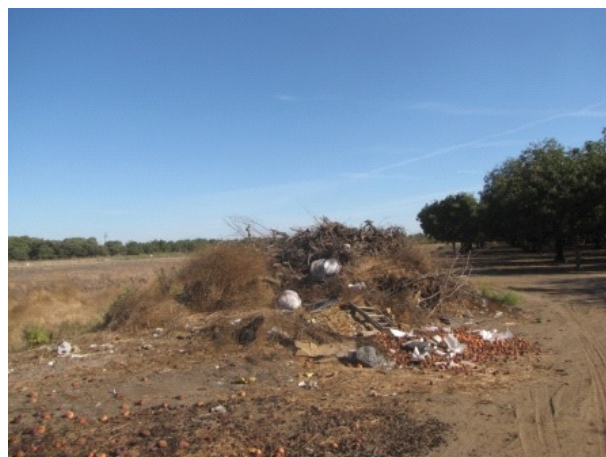
Levee Mile Report Line	17
Start Levee Mile	3.78
End Levee Mile	3.78
Location	Water Side
Category	Earthen Levee
Item	Encroachments

Updated view as of October 2010 of the burn pile looking upstream.

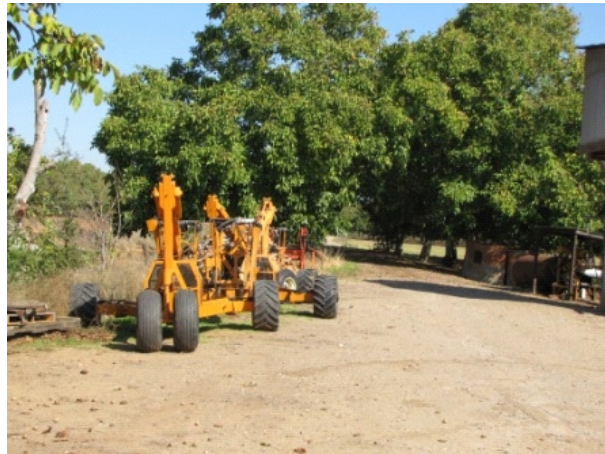
Levee Mile Report Line	23
Start Levee Mile	5.94
End Levee Mile	5.94
Location	Water Side
Category	Earthen Levee
Item	Encroachments
View of equipment located on the waterward side looking upstream.	
dpesaven_f_20100928_365.jpg

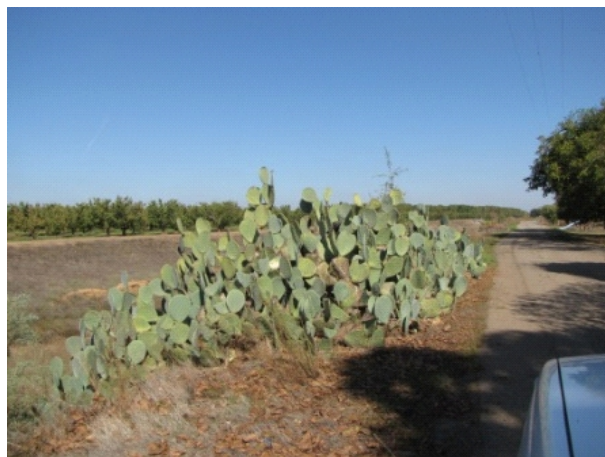
Levee Mile Report Line	27
Start Levee Mile	6.18
End Levee Mile	6.18
Location	Water Side
Category	Earthen Levee
Item	Encroachments
View of cacti located on waterward side looking upstream.	
dpesaven_f_20100928_362.jpg

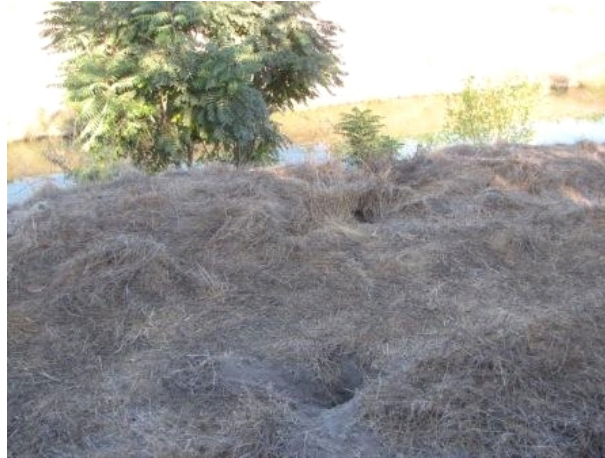
dpesaven_f_20101014_484.jpg

View of rodent holes looking upstream.

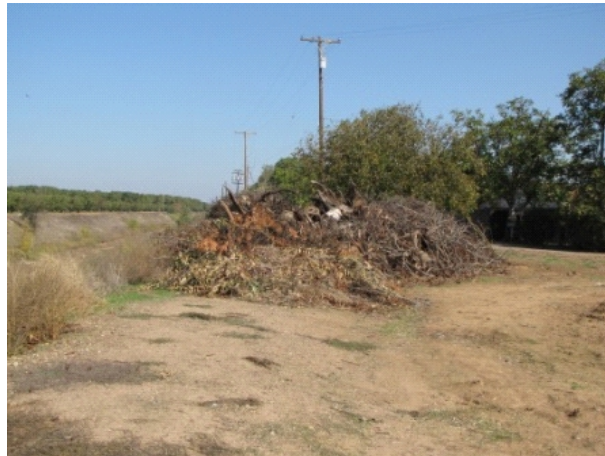
Levee Mile Report Line	34
Start Levee Mile	6.32
End Levee Mile	6.32
Location	Water Side
Category	Earthen Levee
Item	Encroachments

View of a large prunings pile on waterward side and access road blocking visibility and access looking upstream.

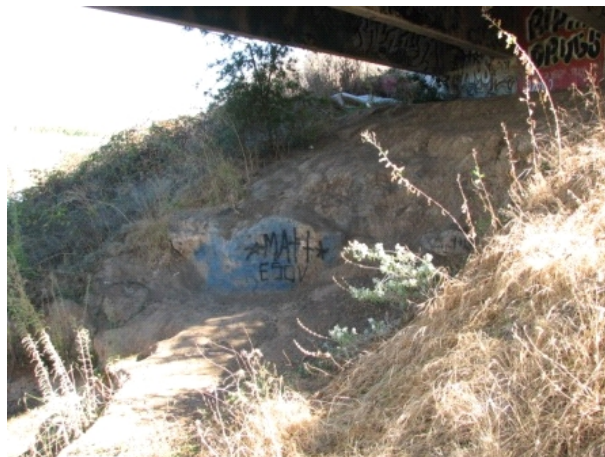
Levee Mile Report Line	35
Start Levee Mile	6.47
End Levee Mile	6.48
Location	Water Side
Category	Supplemental
Item	DWR Erosion Survey

Close up view of the erosion under the Milton Bridge, left bank.

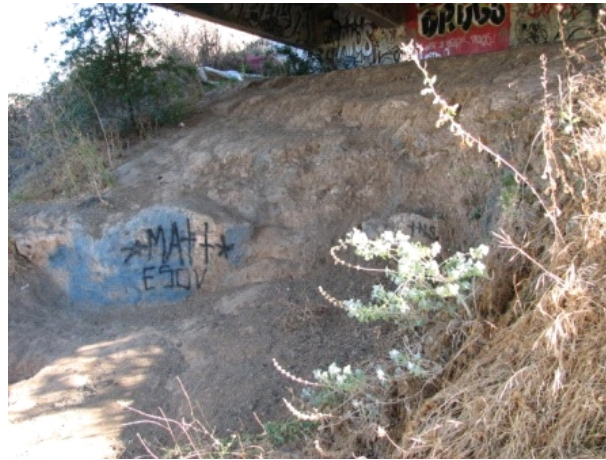
SJR2010_RM6.47U16LM6.47LBb.jpg

Close up view of the erosion pocket.

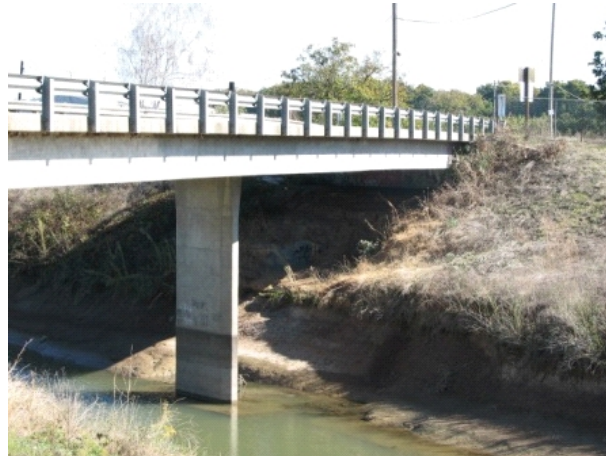
Levee Mile Report Line	35
Start Levee Mile	6.47
End Levee Mile	6.48
Location	Water Side
Category	Supplemental
Item	DWR Erosion Survey

Upstream view of the bridge scour below the east end abutment of Milton Bridge.

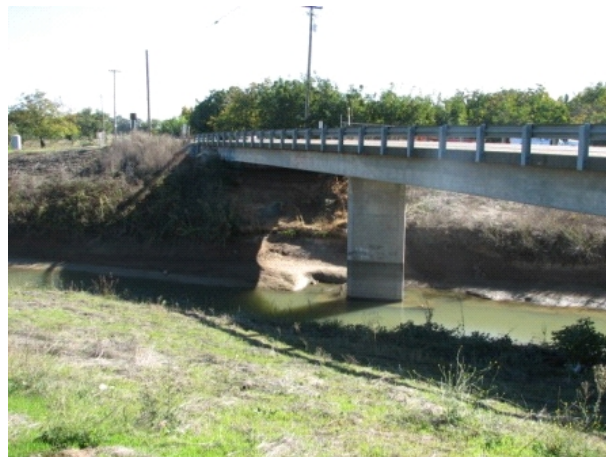
Levee Mile Report Line	35
Start Levee Mile	6.47
End Levee Mile	6.48
Location	Water Side
Category	Supplemental
Item	DWR Erosion Survey

Downstream view of the bridge scour.

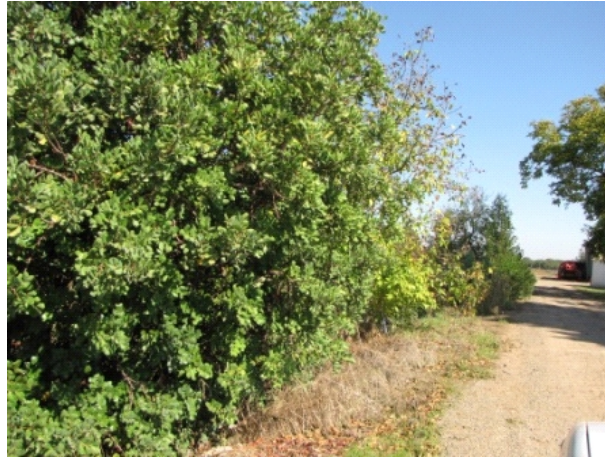
dpesaven_f_20100928_361.jpg

View of landowner planted and maintained landscaping and vegetation along the waterward side looking upstream.

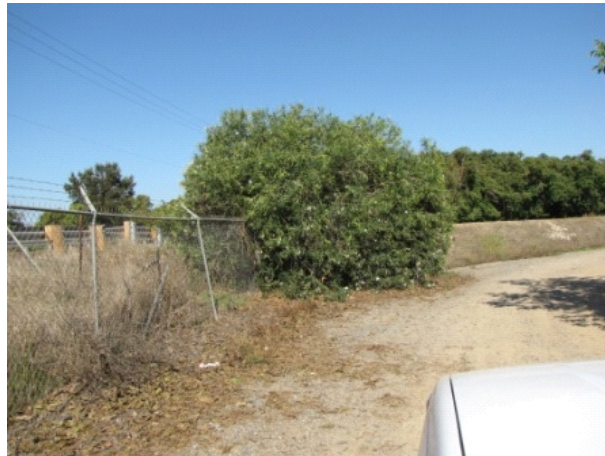
View of an oleander bush along the waterward side obstructing access and visibility.

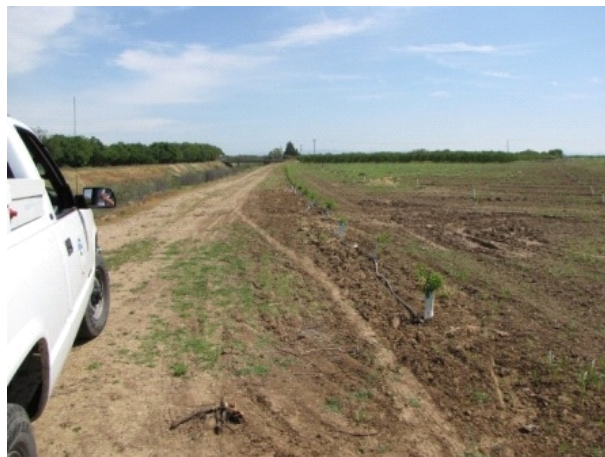
Levee Mile Report Line	38
Start Levee Mile	7.11
End Levee Mile	7.29
Location	Land Side
Category	Earthen Levee
Item	Encroachments

Recently planted trees are within 10' of landward toe of levee. These trees are an encroachment and are potentially future maintenance issues.

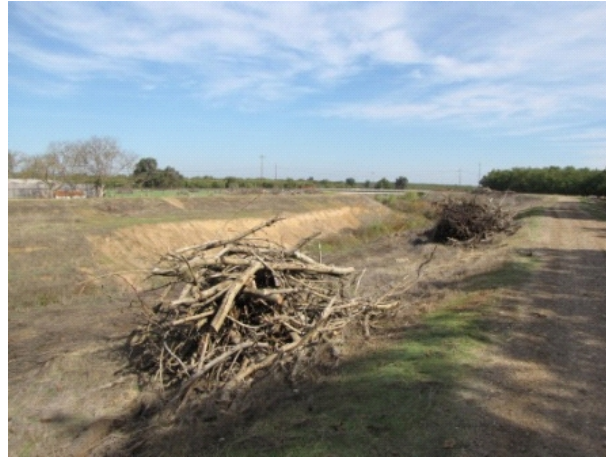
View of pruning piles located on waterward side looking upstream.

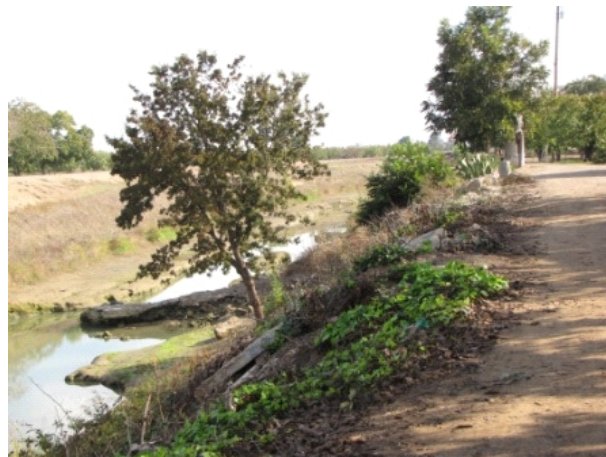
Levee Mile Report Line	56
Start Levee Mile	10.84
End Levee Mile	10.88
Location	Water Side
Category	Earthen Levee
Item	Encroachments

View of landscaping on waterward side looking upstream.

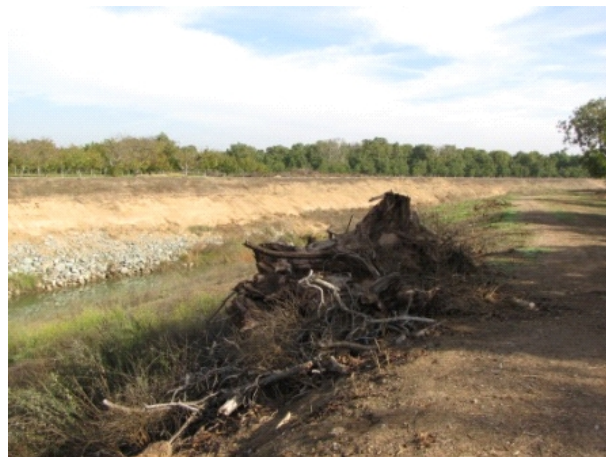
Levee Mile Report Line	57
Start Levee Mile	11.07
End Levee Mile	11.07
Location	Water Side
Category	Earthen Levee
Item	Encroachments

View of prunings located on waterward side looking upstream.

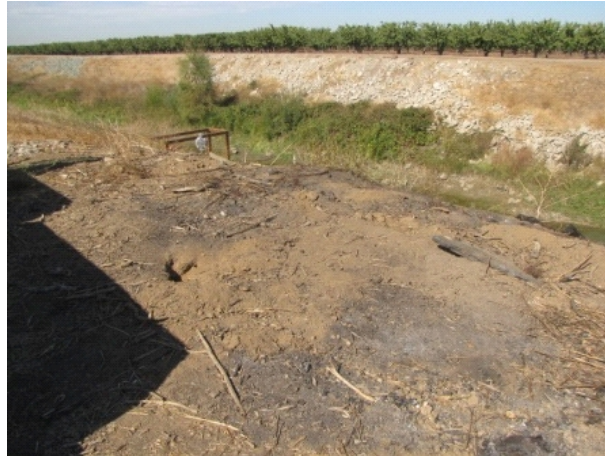
View of rodent activity on the waterward shoulder looking downstream.

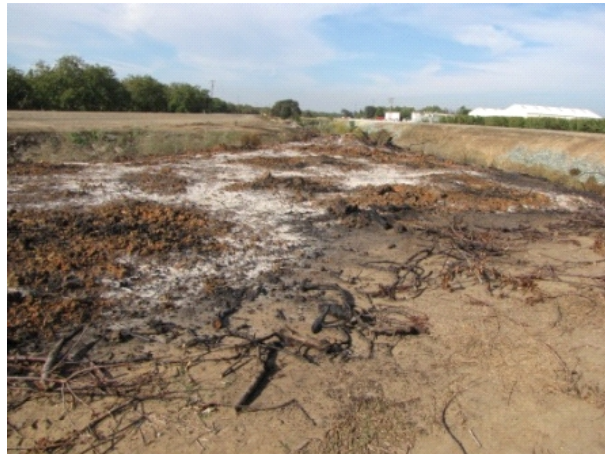
Levee Mile Report Line	60
Start Levee Mile	11.41
End Levee Mile	11.41
Location	Water Side
Category	Earthen Levee
Item	Encroachments

View of location where prunings were burned on waterward side and access road looking downstream.

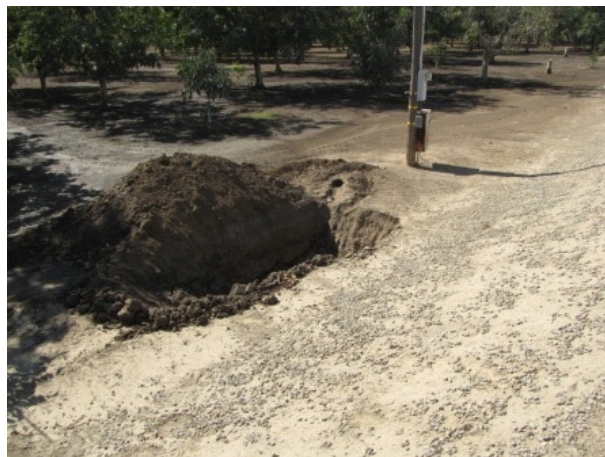
Levee Mile Report Line	62
Start Levee Mile	11.51
End Levee Mile	11.51
Location	Land Side
Category	Earthen Levee
Item	Erosion / Bank Caving

View of the pit dug at the toe of the levee looking downstream.

62	11.51	11.51	Earthen Levee	Erosion / Bank Caving	LS		Schedule repair of erosion site prior to the next inspection. Inspector Comments: Pit dug within 10' of landward toe. Possible leaking pipe at this location and the pit is to pool the leaking water. The pipe will likely need to be repaired and the pit filled.	37.960182 ° -121.165306 °	37.960182 ° -121.165306 °	83 Y
63	11.52	11.59	Earthen Levee	Encroachments	WS	M	Equipment	37.960282 ° -121.165380 °	37.960118 ° -121.166580 °	88 Y
64	11.56	11.56	Earthen Levee	Animal Control	LS	M	Exterminate rodents and backfill and compact or grout burrows.	37.960104 ° -121.166055 °	37.960104 ° -121.166055 °	84 Y

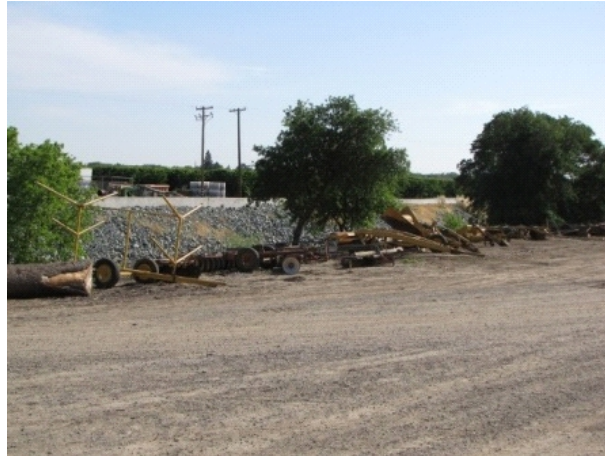
Levee Mile Report Line	63
Start Levee Mile	11.52
End Levee Mile	11.59
Location	Water Side
Category	Earthen Levee
Item	Encroachments
Remove equipment from waterward side of levee.	
dpesaven_f_20100928_319.jpg
